# 8 Messages

# Advisory Messages

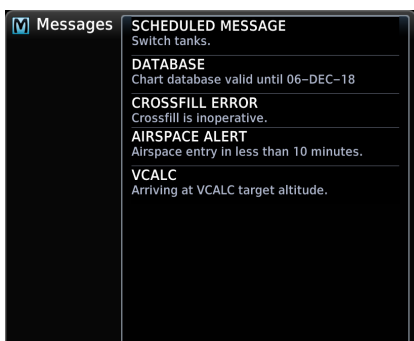
**Message List**

Advisories are system-related messages relative to the display.

- Most recent advisories appear at the top of the message list
- View-once advisories remain in queue until viewed by the pilot
- Persistent (or conditional) advisories remain active until the indicated condition is resolved
