## 16 MESSAGES

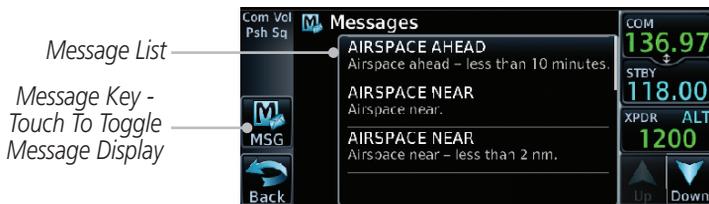
Figure 16-1 Message Display

When an Message has been issued by the unit, the **MSG** (Message) key/annunciator on the left side of the display will blink. Touch the **MSG** key to view the messages. After viewing the messages, touch the **Back** key to return to the previously viewed page.
